# BRIDGE INSPECTION REPORT CITY OF GOSHEN, INDIANA

**PHASE II - 2022**

**PROJECT No. 2020-0015**

**BRIDGE INSPECTION REPORT  
CITY OF GOSHEN  
ELKHART COUNTY  
INDIANA**

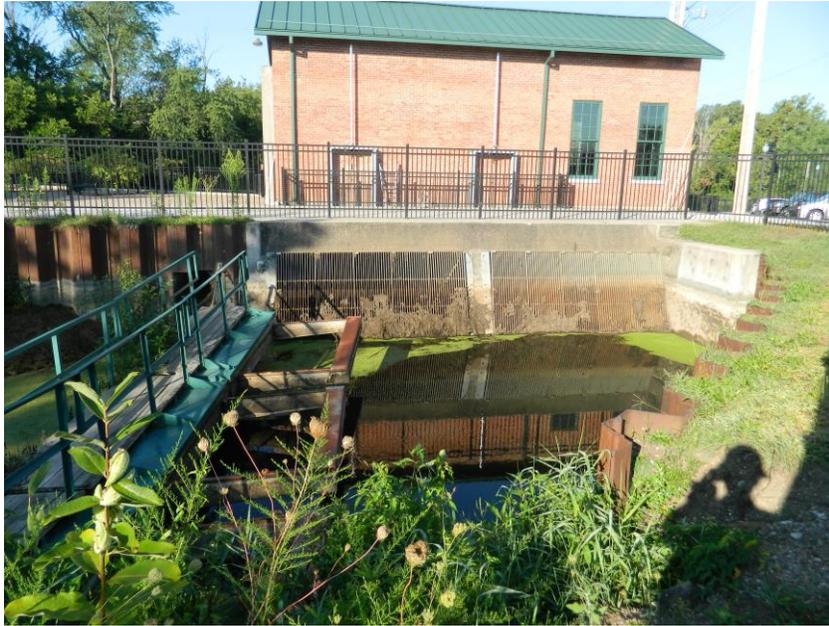
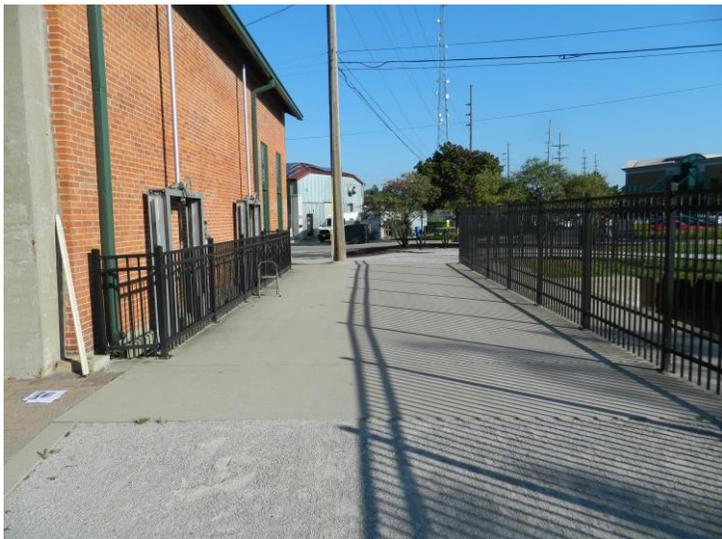
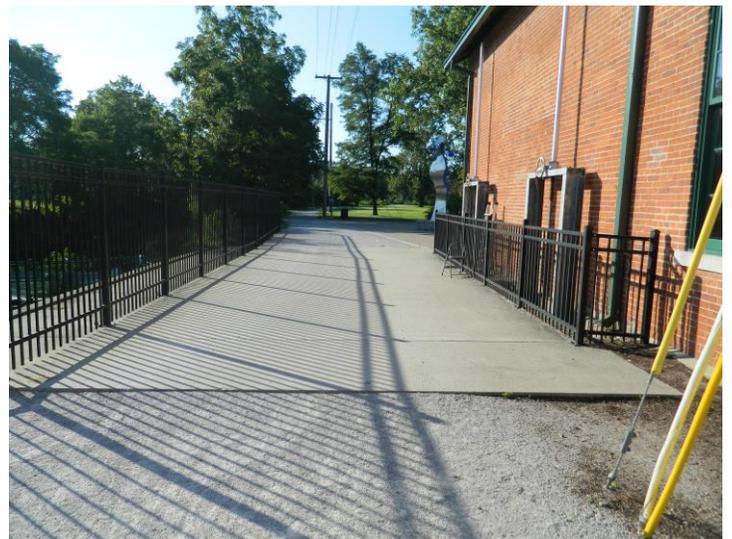
**CITY OF GOSHEN BRIDGE NO. 300**

CONDITION  
Deck: VERY GOOD  
Wearing Surface: VERY GOOD  
Superstr: VERY GOOD  
Substr: FAIR - ABRASION/ SCALING/ WORN  
Channel: GOOD  
Culvert: NA  
Approach Roadway: GOOD - TRAIL - MINOR CRACKS IN RCBA

Structural: FAIR - CONCRETE ABUTMENTS AND CENTER PIER ARE WORN WITH SCALING AND ABRASION  
Geometry: GOOD - TRAIL  
Bridge Railing: VERY GOOD - STEEL PEDESTRIAN RAIL  
Waterway Adequacy: OVER HYDRAULIC CANAL WITH FLOW CONTROL  
Roadway Alignment: STRAIGHT AND LEVEL - TRAIL  
Scour: STABLE  
Foundation: UNKNOWN (LIKELY SPREAD FOOTING)

ACCESS TO SUBSTRUCTURE IS OBTAINED BETWEEN WEST COPING AND POWERHOUSE. A 20' EXTENSION LADDER, 3' STEP LADDER, AND CANAL MUST BE LOWERED AT A MINIMUM FOR ACCESS. MINOR CRACKING IN REINFORCED CONCRETE APPROACH SLABS. HONEYCOMBING IN BEAM 4 FROM WEST IN SOUTH SPAN. BEARING PAD AT N END OF BEAM 2 FROM WEST IN SOUTH SPAN IS WALKING OUT.

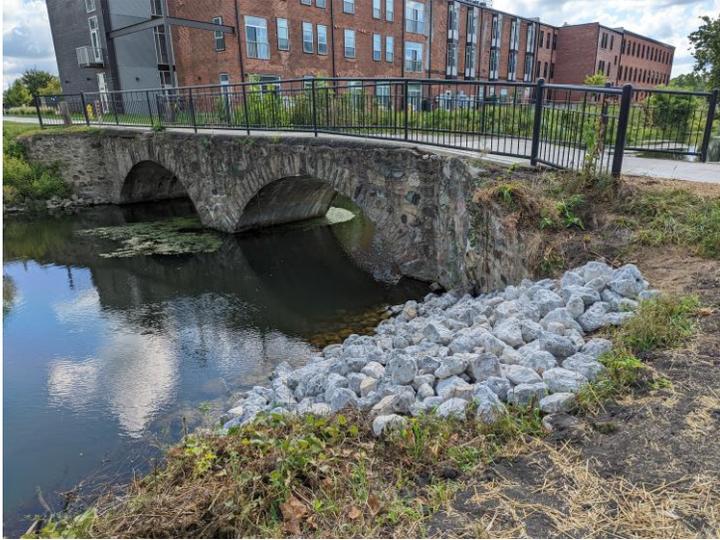
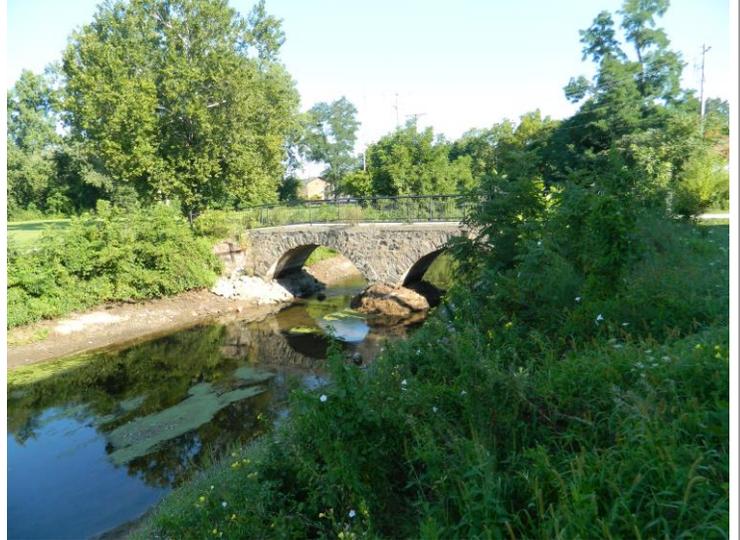
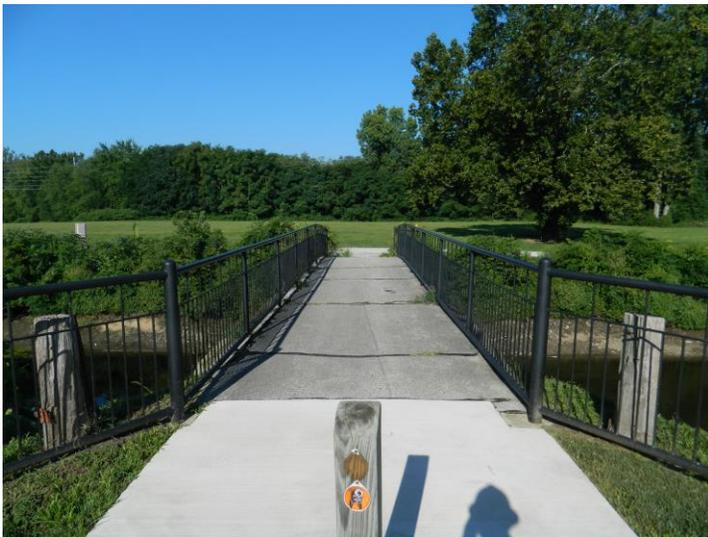
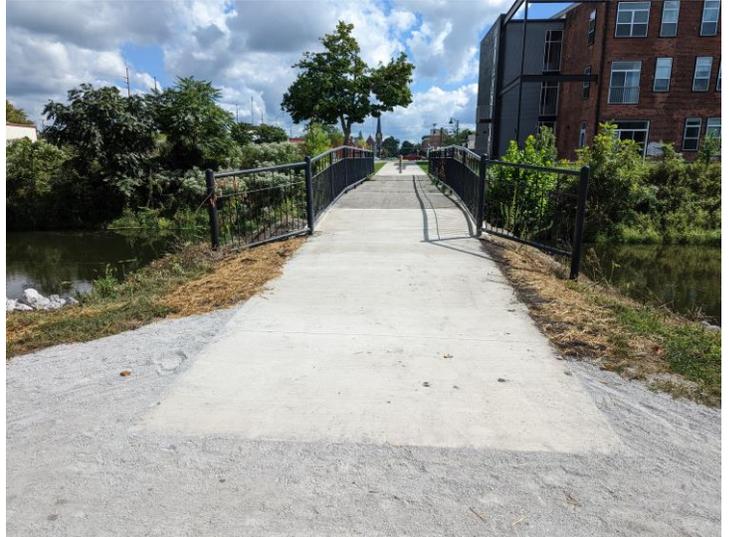
**CITY OF GOSHEN BRIDGE NO. 301**

<u>CONDITION</u>	<u>MATERIAL</u>	<u>RATING</u>
Deck: NA	NA	NA
Wearing Surface: FAIR - TRANSVERSE CRACKS / SETTLEMENT AND EROSION	BITUMINOUS	5
Superstr: SATISFACTORY - CRACKS AND EFFLORESCENCE	STONE MASONRY	6
Substr: SATISFACTORY - ABRASION	STONE MASONRY	6
Channel: GOOD	EARTH AND RIPRAP	7
Culvert: NA	NA	NA
Approach Roadway: GOOD - RECENTLY REPAVED	CONCRETE	7

<u>APPRAISAL</u>	<u>RATING</u>
Structural: SATISFACTORY- CRACKING AND LEACHING OF ARCHES	6
Geometry: GOOD - TRAIL	7
Bridge Railing: GOOD - STEEL PEDESTRIAN HANDRAIL	7
Waterway Adequacy: OVER HYDRAULIC CANAL WITH FLOW CONTROL	9
Roadway Alignment: STRAIGHT AND LEVEL- TRAIL	8
Scour: STABLE - RIPRAP ADDED AT ABUTMENTS AND PIER	5
Foundation: SPREAD FOOTING

EAST APPROACH HAS RECENTLY BEEN REDONE AS PART OF THE CONSTRUCTION OF THE ADJACENT BUILDING. WEST APPROACH REPAIRED IN SEPTEMBER 2022. NEW CONCRETE SIDEWALK APPROACHES. BRIDGE ADEQUATE FOR PEDESTRIAN TRAFFIC ONLY. THE MASONRY IS SOLID WITH NO LOOSE STONES FOUND. THE BRIDGE SHOULD BE KEPT CLEAR OF VEGETATIVE GROWTH. PATCHES ON EAST SPAN IN GOOD CONDITION. RIPRAP AROUND ABUTMENTS AND PIER. RIPRAP IN NORTHEAST AND SOUTHEAST CORNERS. RIPRAP AT SOUTHEAST CORNER IS ERODING. RIPRAP AT NORTHWEST AND SOUTHWEST BANKS WERE RECENTLY ADDED IN SEPTEMBER 2022. MASONRY REPOINTING IN GOOD CONDITION. ABRASION AT WEST ABUTMENT AT ORDINARY HIGH WATER MARK. ABRASION AT WEST SIDE OF PIER. CRACKING WITH LEACHING IN WEST SPAN NEAR PIER. SPALLING AND DETERIORATION AT SOUTHWEST WINGWALL.

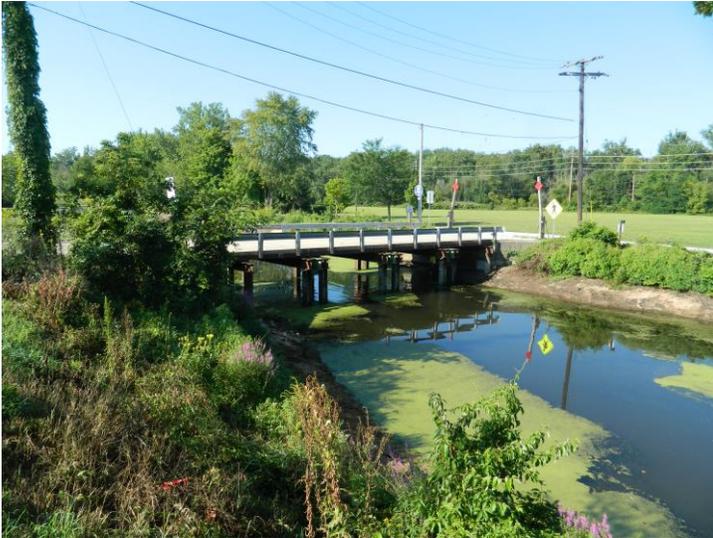
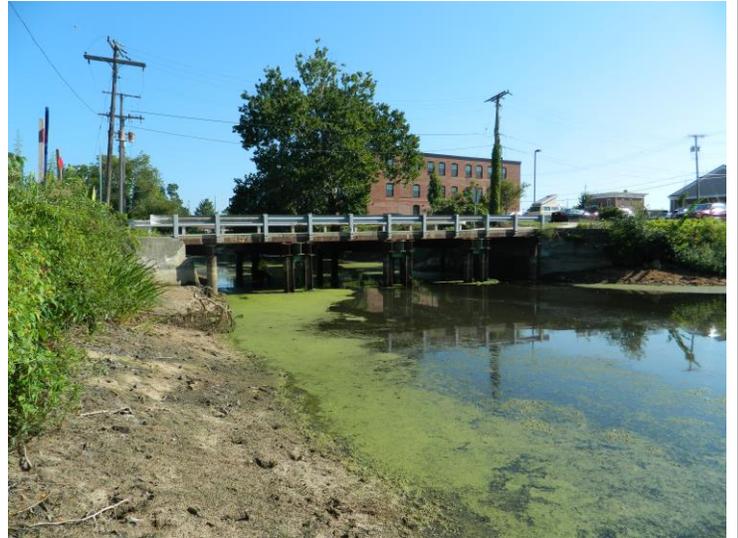
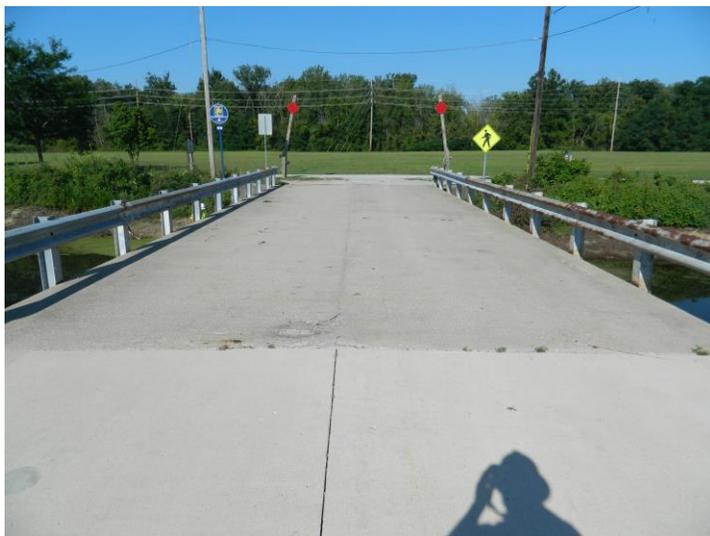
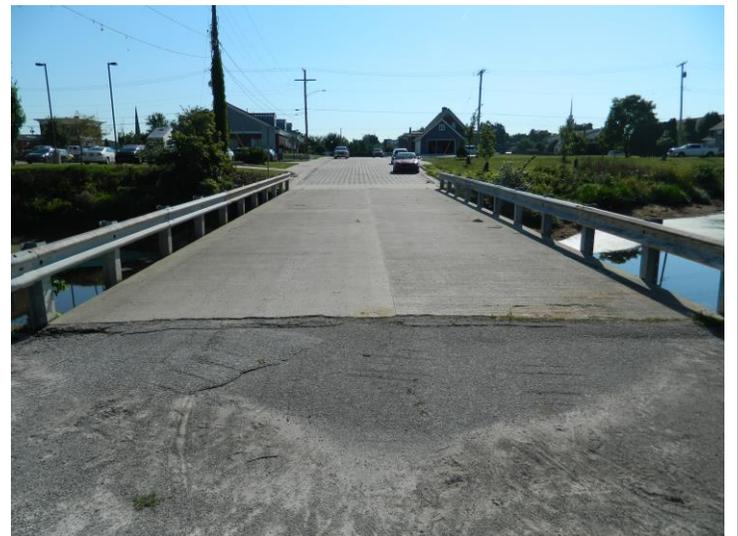
**CITY OF GOSHEN BRIDGE NO. 302**

<u>CONDITION</u>	<u>MATERIAL</u>	<u>RATING</u>
Deck:	FAIR - TRANSVERSE CRACKING, EFFLORESCENCE, SPALLING	CONCRETE	5
Wearing Surface:	FAIR - POTHOLES, DELAMINATION IN SW CORNER	MONOLITHIC CONCRETE	5
Superstr:	FAIR - EXPOSED BOTTOM FLANGES HAVE DETERIORATION/SECTION LOSS	CONCRETE ENCASED STEEL BEAM	5
Substr:	POOR - BENT CAPS WITH HEAVY SURFACE RUST AND HEAVY SECTION LOSS	STEEL PILE BENTS AND CONC. ABUTMENTS	4
Channel:	SATISFACTORY - FLOWS AGAINST EAST ABUTMENT	EARTH	6
Culvert:	NA	NA	NA
Approach Roadway:	GOOD	BITUMINOUS AT WEST APPROACH. CONCRETE AND BRICK PAVERS AT EAST APPROACH	7

<u>RATING</u>
Structural: POOR - HEAVY CORROSION OF H-PILES/ SECTION LOSS AT STEEL CAP BEAMS	4
Geometry: SOMEWHAT BETTER THAN MINIMUM ADEQUACY TO LEAVE IN PLACE	5
Bridge Railing: FAIR - STEEL W-BEAM - SUBSTANDARD	5
Waterway Adequacy: OVER HYDRAULIC CANAL WITH FLOW CONTROL	9
Roadway Alignment: STRAIGHT AND LEVEL / NO SPEED REDUCTION REQUIRED	8
Scour: STABLE	5
Foundation: PILES AND SPREAD FOOTINGS

SURFACE SPALL AT CENTER OF DECK. DELAMINATED AREA IN SOUTHWEST CORNER OF DECK. EROSION BEHIND SOUTHWEST, SOUTHEAST, AND NORTHEAST WINGWALLS. HEAVY RUST ON H-PILES WITH MODERATE SECTION LOSS. CROSS BEAMS IMMEDIATELY ADJACENT TO ABUTMENTS (BENTS 2 & 6) HAVE SEVERE SECTION LOSS/DETERIORATION OF FLANGES AND 100% SECTION LOSS OF WEB, NO LONGER SUPPORTING SUPERSTRUCTURE. OLD BENT CAPS AT BENTS 3, 4 & 5 WITH AREAS OF 100% SECTION LOSS OF WEBS AND HEAVY RUST THROUGHOUT. NEW BENT CAPS INSTALLED AT BENTS 3, 4 & 5 IN 2008. MINOR TO MODERATE SECTION LOSS OF EXPOSED BOTTOM FLANGES OF SUPERSTRUCTURE BEAMS. DECK UNDERSIDE HAS SPALLING AND EXPOSED, CORRODED REINFORCING. 1" CRACK IN EAST ABUTMENT. WATER FLOWS AGAINST EAST ABUTMENT. SHIMS INSTALLED IN 2012 TO PROVIDE POSITIVE BEARING OF SUPERSTRUCTURE BEAMS TO ORIGINAL BENT CAP BEAMS AT BENTS 3, 4 & 5. GATES AT WEST APPROACH ARE LIFTED. NO GATE AT EAST APPROACH. NO LOAD POSTING SIGNS. CRACKING AND DETERIORATION OF WEST ABUTMENT AT BEARING SEATS. CONCRETE APPROACH SLAB AND BRICK PAVERS AT EAST APPROACH.

NOT ELIGIBLE Year Needed: 2026  
City Type Work: REPLACEMENT - CONTRACT  
City  
REPLACE STRUCTURE WITH NEW VEHICULAR BRIDGE.

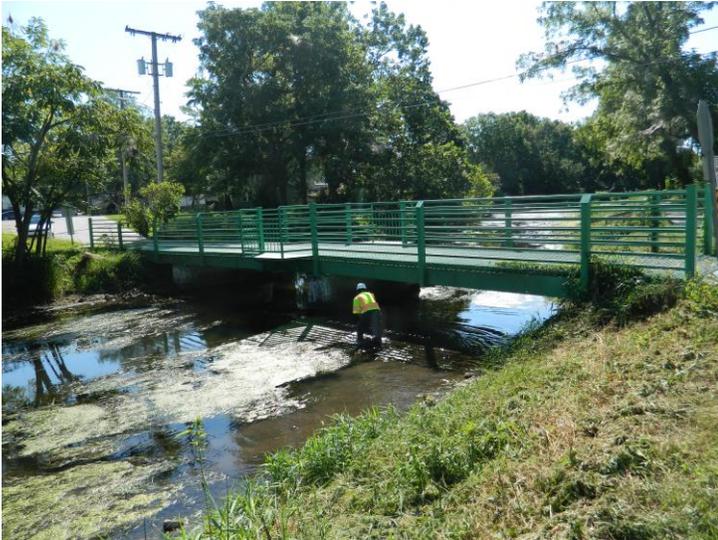
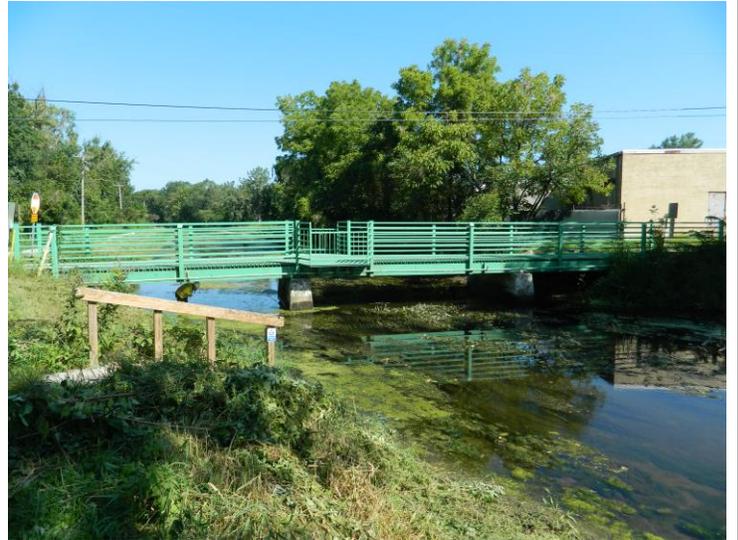
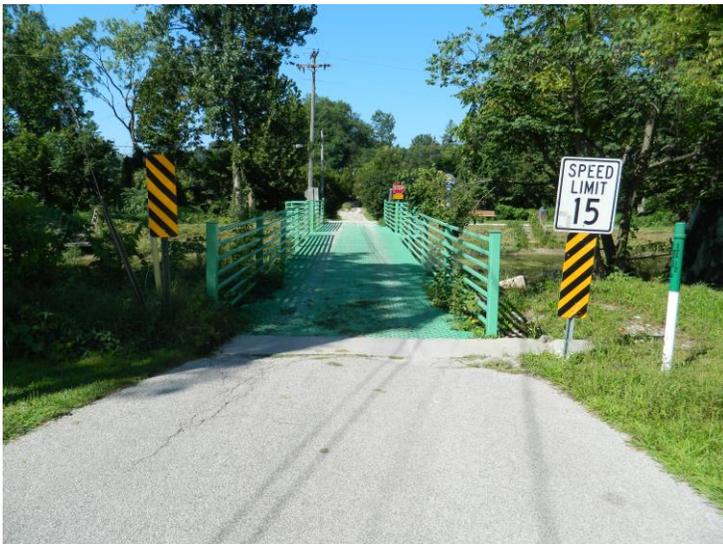
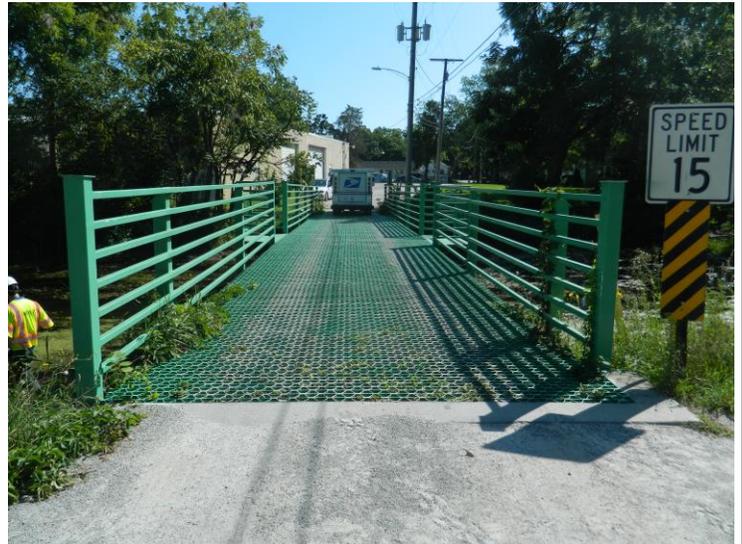
**CITY OF GOSHEN BRIDGE NO. 305**

<u>CONDITION</u>	<u>MATERIAL</u>	<u>RATING</u>
Deck: GOOD	BOLTED STEEL GRATE	7
Wearing Surface: GOOD	STEEL	7
Superstr: FAIR - HEAVY PITTING, MODERATE SECTION LOSS AT FLANGES	STEEL	5
Substr: FAIR - CRACKING/ EFFLOR. AT PIER ENDS, MINOR UNDERMINING AT W. PIER	CONCRETE	5
Channel: SATISFACTORY - SCOUR AT SOUTH END OF PIERS	EARTH AND RIPRAP	6
Culvert: NA	NA	NA
Approach Roadway: CRACKED AT EAST APPROACH	BITUMINOUS	6

<u>APPRAISAL</u>	<u>RATING</u>
Structural: FAIR - SCOUR AT SOUTH END OF PIERS. MINOR UNDERMINING AT WEST PIER. BEAM SECTION LOSS WITH HEAVY PITTING	5
Geometry: MEETS MINIMUM TOLERABLE LIMITS TO LEAVE IN PLACE	4
Bridge Railing: GOOD - STEEL TUBE - DOES NOT MEET STANDARDS	7
Waterway Adequacy: OVER HYDRAULIC CANAL WITH FLOW CONTROL	8
Roadway Alignment: STRAIGHT AND LEVEL, MINOR SPEED REDUCTION REQUIRED. TRAIL INTERSECTION AT WEST END.	6
Scour: STABLE - PREVENTIVE ACTION REQUIRED	4
Foundation: UNKNOWN (LIKELY SPREAD FOOTING)

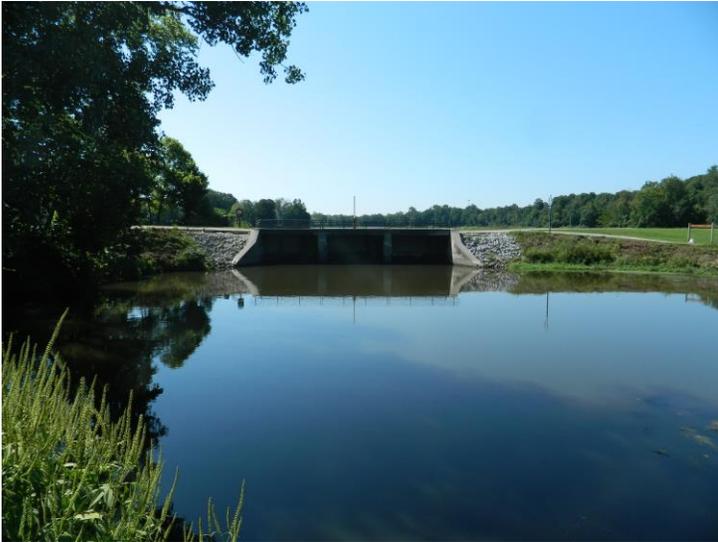
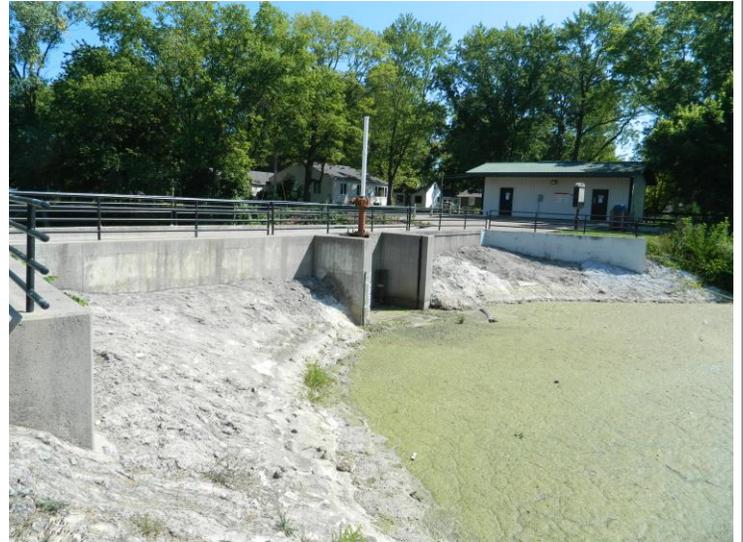
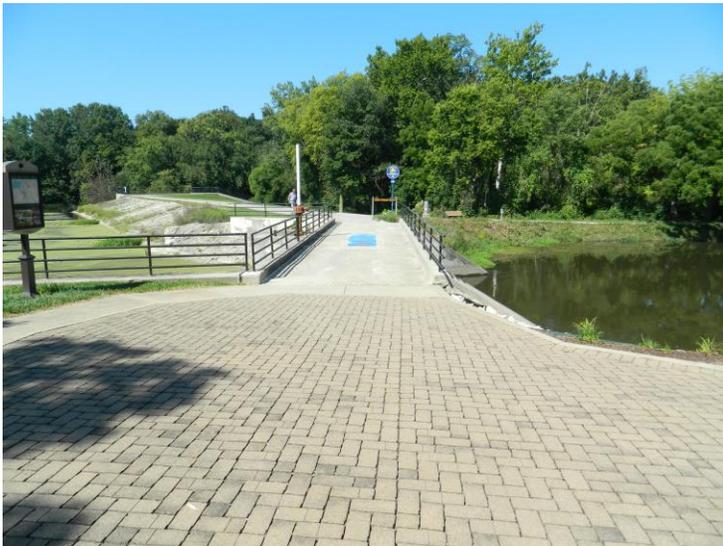
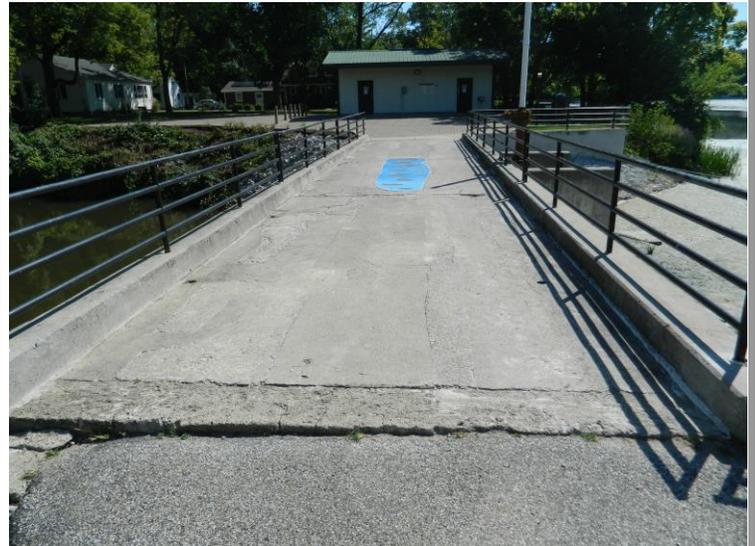
**CITY OF GOSHEN BRIDGE NO. 306**

CONDITION  
Deck: SATISFACTORY - ROUGH/ SCALING & CRACKING  
Wearing Surface: SATISFACTORY - ROUGH/UNEVEN  
Superstr: CRACKING AND LEACHING / EXPOSED BOTTOM FLANGE  
Substr: HEAVY CRACKING AND LEACHING / ABRASION BELOW WATERLINE  
Channel: GOOD - AT GOSHEN DAM  
Culvert: NA  
Approach Roadway: GOOD

<u>APPRAISAL</u>	<u>RATING</u>
Structural: FAIR - HEAVY CRACKING AND LEACHING	5
Geometry: GOOD - TRAIL	7
Bridge Railing: GOOD - STEEL TUBE - DOES NOT MEET STANDARDS	7
Waterway Adequacy: OVER HYDRAULIC CANAL WITH FLOW CONTROL	9
Roadway Alignment: STRAIGHT AND LEVEL - TRAIL	8
Scour: STABLE	5
Foundation: UNKNOWN (LIKELY SPREAD FOOTING)

DECK SURFACE IS ROUGH AND UNEVEN, EXHIBITING ABRASION AND CRACKING. HEAVY CRACKING WITH LEACHING AT UNDERSIDE OF STRUCTURE AND PIER WALLS. 8" THICK REINFORCED CONCRETE SLAB SUPPORTED ON ENCASED STEEL BEAMS. THE BOTTOM FLANGE OF THE BEAMS ARE EXPOSED, EXHIBITING SURFACE RUST. GROUTED RIPRAP AT POND SIDE. VOIDS IN THE GROUTED RIPRAP WERE FIXED IN 2021. MINOR EROSION BEHIND THE NORTHWEST AND NORTHEAST WINGWALLS.

NOT ELIGIBLE Year Needed: 2030  
City Type Work: REHABILITATION - CONTRACT  
City  
REMOVE AND REPAIR UNSOUND CONCRETE. EPOXY  
INJECT CRACKS. MILL AND OVERLAY CONCRETE DECK.

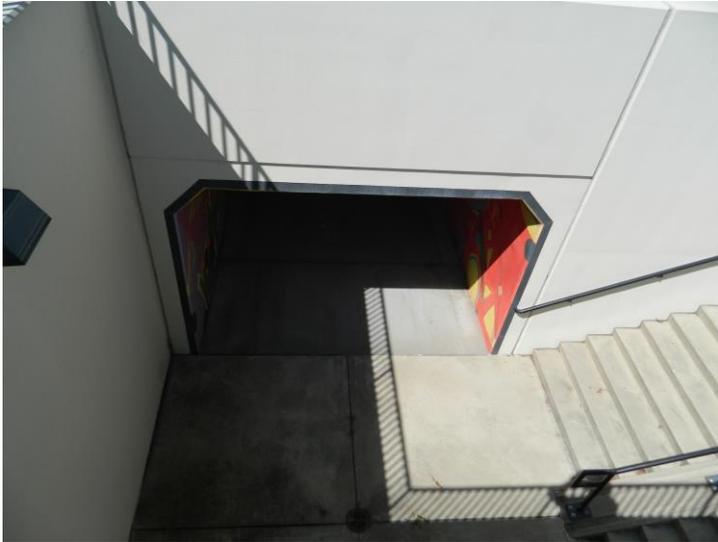
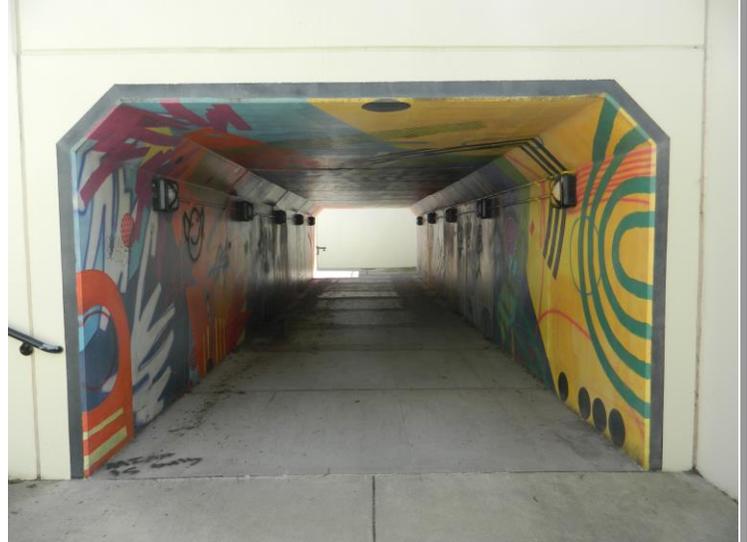
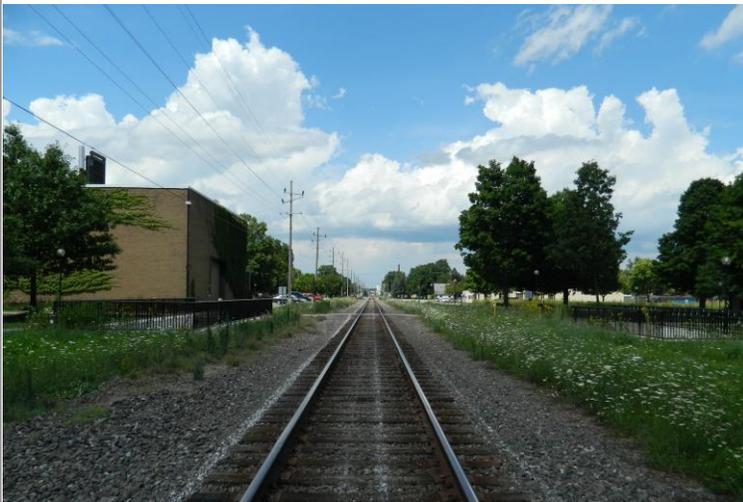
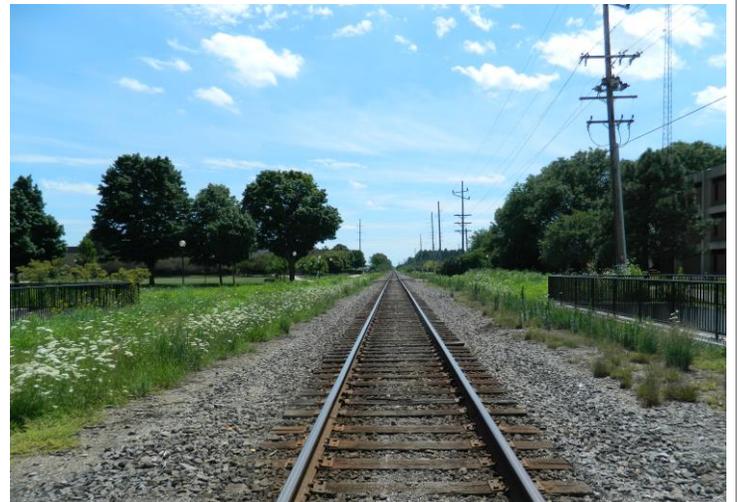
**CITY OF GOSHEN BRIDGE NO. 402  
NORFOLK SOUTHERN RAILROAD  
OVER  
WINONA TRAIL BIKE**

**CONDITION**  
 Deck: **NA - UNDER RAILROAD FILL**  
 Wearing Surface: **GOOD**  
 Superstr: **NA**  
 Substr: **NA**  
 Channel: **NA - NOT OVER WATERWAY**  
 Culvert: **GOOD - MINOR SURFACE SPALLS/ SHRINKAGE CRACKS**  
 Approach Roadway: **CRACKING IN WEST APPROACH STAIRS**

**APPRAISAL** **RATING**  
 Structural: **GOOD CONDITION** **7**  
 Geometry: **GOOD - CONCRETE STAIRWELL** **7**  
 Bridge Railing: **GOOD - STEEL HANDRAIL** **7**  
 Waterway Adequacy: **NA - NOT OVER WATERWAY** **NA**  
 Roadway Alignment: **TRAIL UNDER RAILROAD** **8**  
 Scour: **NA - NOT OVER WATERWAY** **NA**  
 Foundation: **BOX CULVERT**

**CRACKING IN WEST APPROACH SIDEWALK. MINOR SHRINKAGE CRACKS IN CONCRETE RETAINING WALLS, WEST STAIRS. MINOR MAP SURFACE CRACKING IN BOTTOM SLAB OF CULVERT. MINOR SURFACE SPALLS IN UNDERSIDE OF TOP SLAB OF UNIT 2 FROM WEST.**

NOT ELIGIBLE Year Needed: **2025**  
 City Type Work: **REPAIR - LOCAL FORCES**  
 City **REPLACE CRACKED SIDEWALK AT WEST STAIRS APPROACH**
